Technical Series 03-129

## MONITORING THE PERFORMANCE OF A RETROFITTED PRESERVED WOOD FOUNDATION

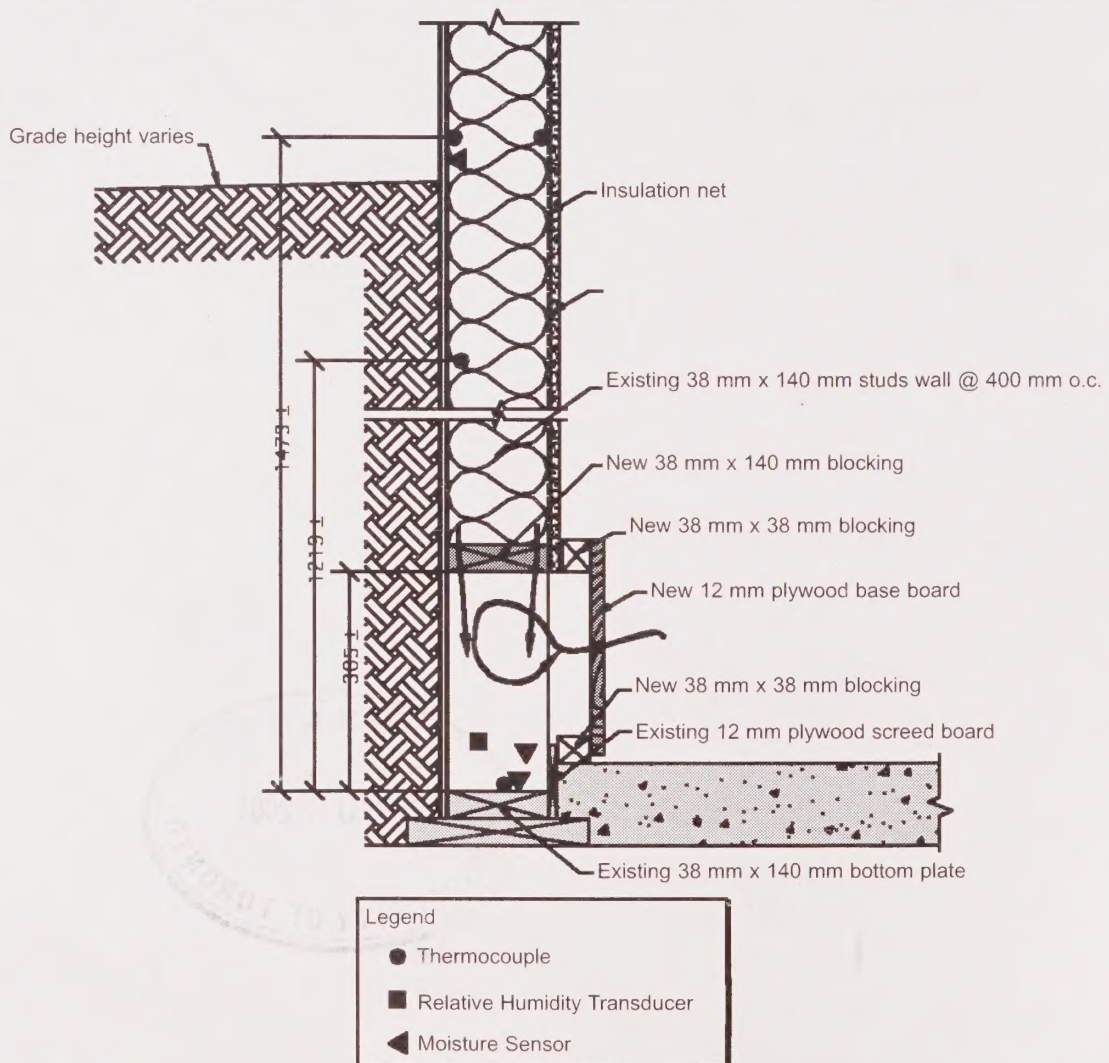
Figure 1. Typical cross-section of PWF wall

Figure 1 shows a typical cross-section of the wall and ventilation cavity, and the location of sensors. The primary findings drawn from this monitoring project were:
